The Importance of Base Metal Thickness  
and Zinc Coating Protection in Steel  
Performance and Compliance

**EDITION 2**

# Beyond Appearances: The Importance of Base Metal Thickness and Zinc Protection in Steel Performance and Compliance

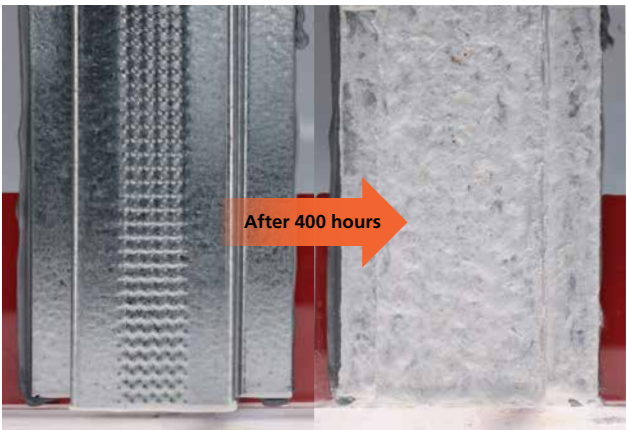
Rondo Top Hat

Even before testing commenced, the imported steel samples showed visible surface defects. By 200 hours, red rust had already formed on the imported steel due to coating failure, and by 400 hours significant corrosion was evident. In contrast, the Rondo samples displayed no visible red rust over the same testing period.

We recently completed Accelerated Corrosive Environmental Testing at an independent laboratory. In this test, a continuous salt mist was sprayed onto both Rondo and imported steel components, with images captured at consistent intervals.

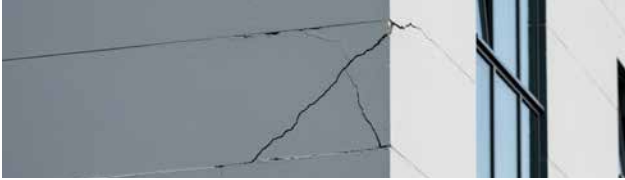
#### Structural adequacy issues

- Reduce load capacity
- Loss of section
- Weaker Connections
- Façade Instability

### a) Structural Adequacy Issues: Why Rusted Top Hats Can No Longer Support Your Façade

Red rust can expand up to 10 times the volume of steel, so when corrosion begins, it progressively eats away at the material while also causing surface expansion.

As corrosion progresses, it results in:

- Reduced steel thickness, lowering the load-carrying capacity
- Weakened connections, particularly fasteners fixed into the corroding Top Hat
- Distortion or buckling, as volumetric expansion pushes the steel out of shape

In façade systems where Top Hats support cladding, these effects can cause:

- Sagging or displacement of cladding
- Premature fatigue and cracking
- Failure to meet design wind-pressure or structural performance requirements

Over time, corroded steel can no longer perform the way it was designed, compromising the stability of the entire façade assembly.

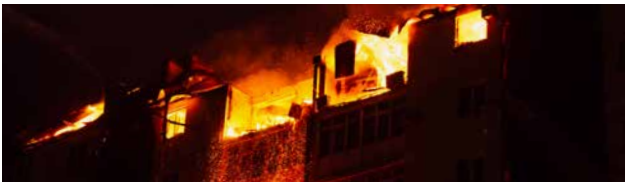
#### Fire Performance Risks

- Earlier structure failure in fire
- Reduce fixing strength
- Increased risk of cladding detachment

### **b) Fire Performance Risks: How Corroded Top Hats Fail Faster Under Fire Conditions**

Corrosion not only weakens steel in normal conditions, it also significantly reduces its performance during a fire.

Steel naturally loses strength when exposed to high temperatures. If corrosion has already reduced the steel's cross-section:

- The material reaches its failure point much sooner in a fire
- Deformation occurs faster, increasing the likelihood of cladding collapse or detachment
- The sub-framing may no longer be able to maintain façade integrity long enough to meet fire performance expectations

Corrosion also degrades fastener threads and reduces pull-out strength. During a fire, materials expand and loads shift, meaning fixings must perform reliably. Rusty Top Hats compromise that reliability, increasing the risk of:

- Cladding panels falling away
- Fire spread pathways opening within the façade cavity
- Falling debris endangering occupants or emergency responders

Simply put, a weakened substrate dramatically undermines the fire performance of the entire façade system.

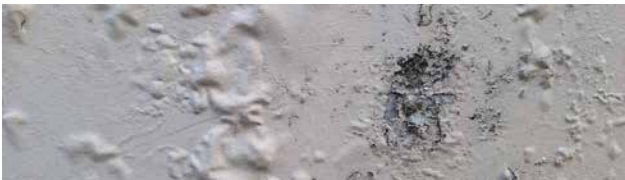
#### Waterproofing issues

- Movement
- Sealant Failure
- Water Ingress
- Mould
- Long-term building damage

### **c) Waterproofing Failures: How Rusty Top Hats Can Lead to Leaks and Façade Damage**

Corrosion also has significant implications for building envelope performance. As steel rusts and expands, it can cause:

- Bowing or distortion of the Top Hat
- Movement at junctions and fixings
- Cracking of cladding boards, joints, and sealants

- Water ingress
- Moisture accumulation behind cladding
- Mould growth
- Long-term deterioration of insulation, sheathing, and framing
- Premature failure of the façade system

Water penetration is one of the most common and most expensive building defects. Premature corrosion of Top Hats magnifies the risks, which can lead to:

- Higher maintenance costs
- Increased insurance and liability exposure
- Remediation works that far exceed any initial cost savings from low zinc-coated imports
